GE LM2500 PE SAC Gas Turbine Borescope Inspection Report

Engine Serial Number:	481-012
Model:	GE LM2500 PE SAC
Power turbine:	LM2500 six stage
Time since last overhaul:	6.490 h
Total hours since new:	Unknown
Rated power:	22.5 MW
Operating mode:	Partial load
Project:	4817243320
Performed by:	P. Blass
Inspection date:	15.12.2020

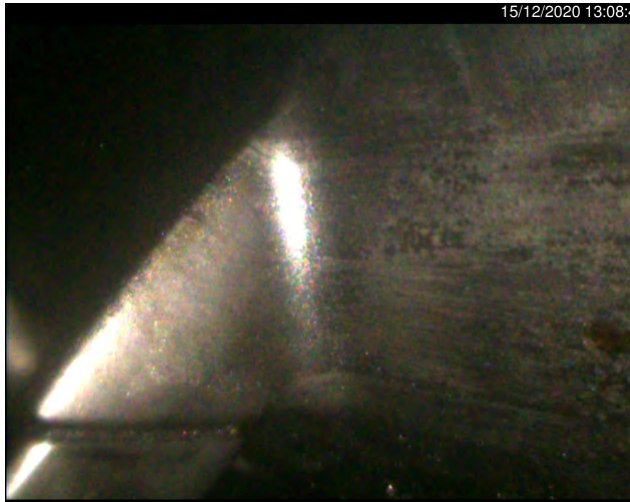
Picture 1: mid span dampers

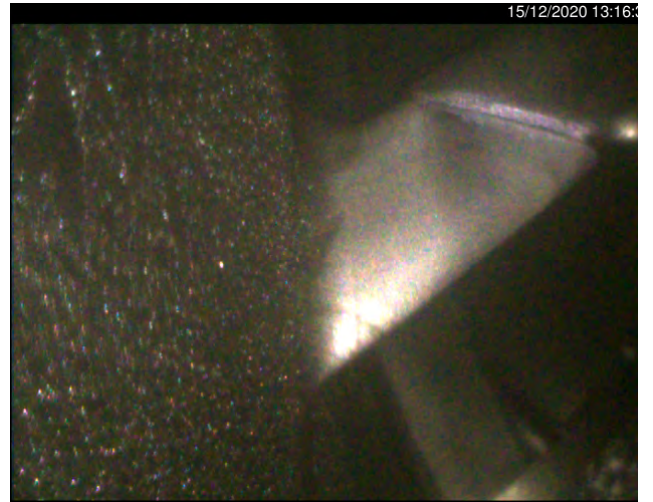
Picture 2: mid span dampers, minor salt

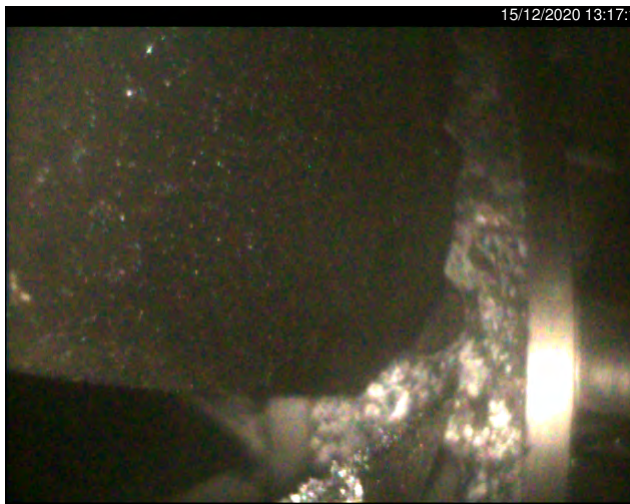
Picture 3: stage 1 shrouds, salt and deposits

Compressor is dirty, water wash recommended.
 L&S screens and chip detectors checked, clean, no findings.
 Continue preventive preservation GEK WP50100 until startup.

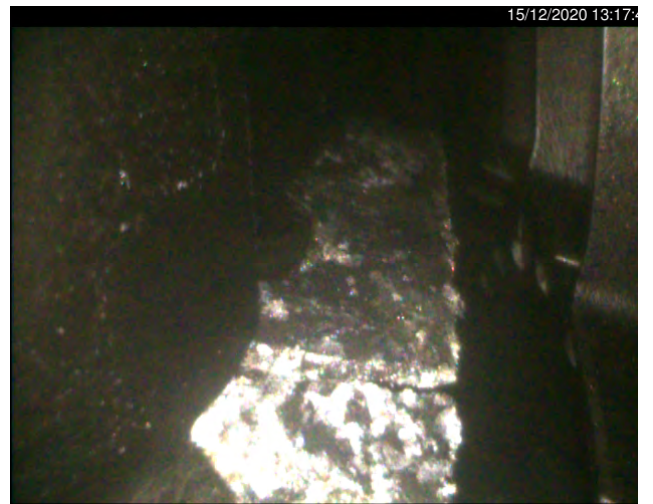
Picture 4: stage 1 shrouds, salt and deposits

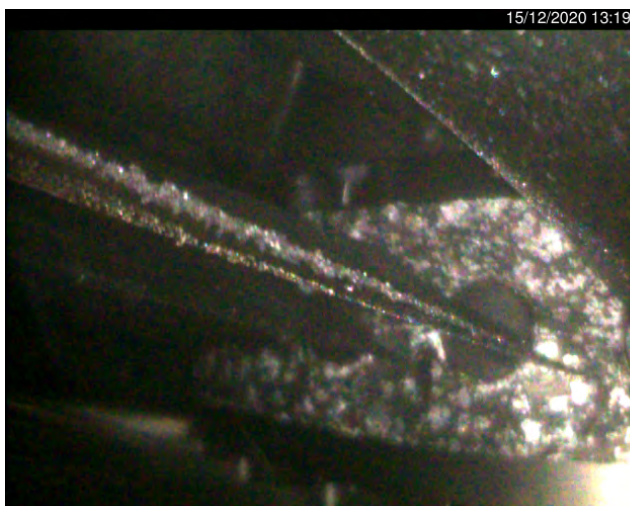
Picture 5: stage 1 shrouds, salt and deposits

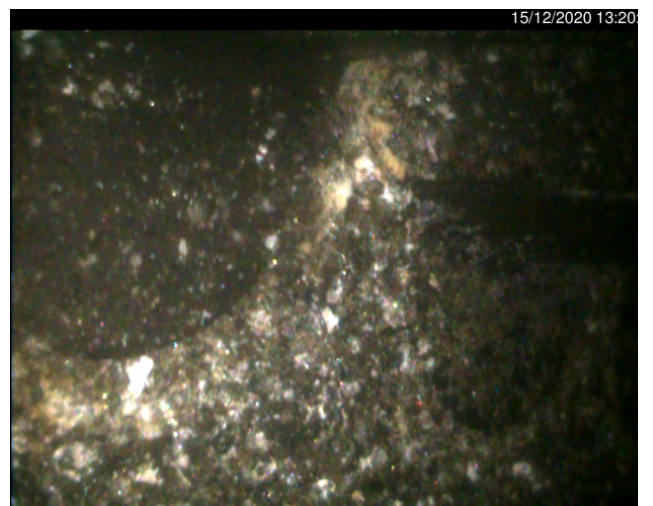
Picture 6: stage 1 shrouds, salt and deposits

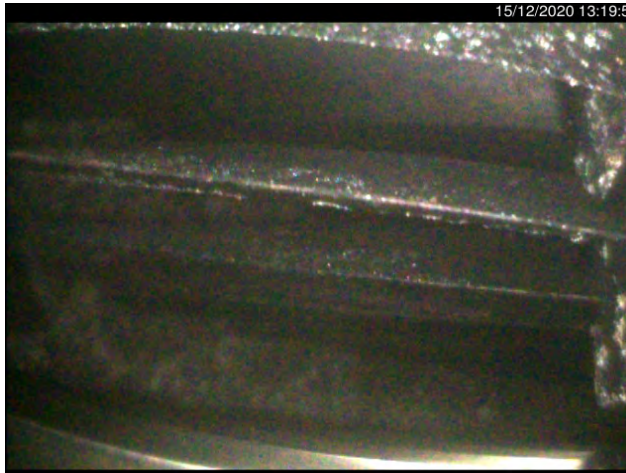
Picture 7: salts and deposits

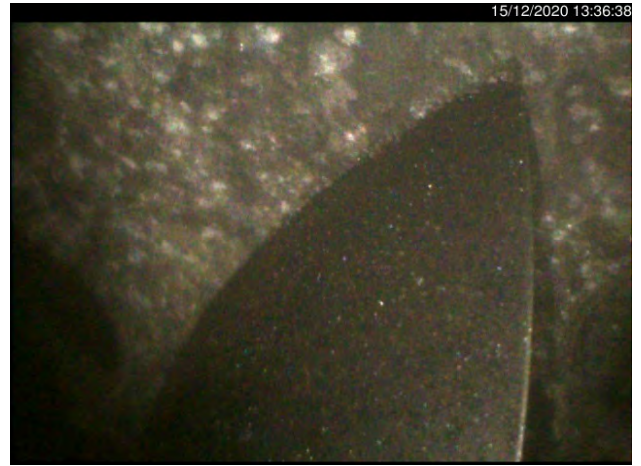
Picture 8: salts and deposits

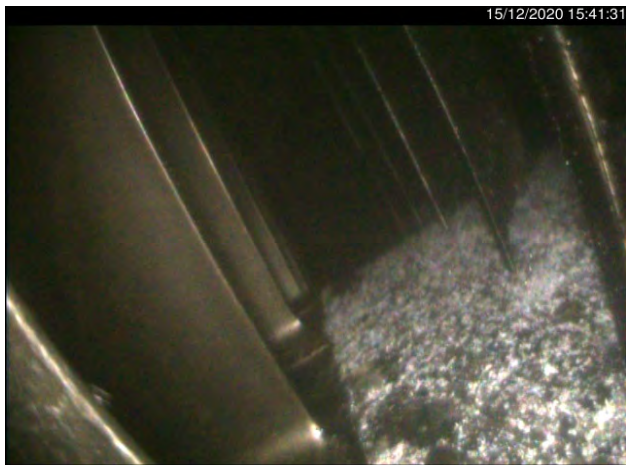
Picture 9: salts and deposits

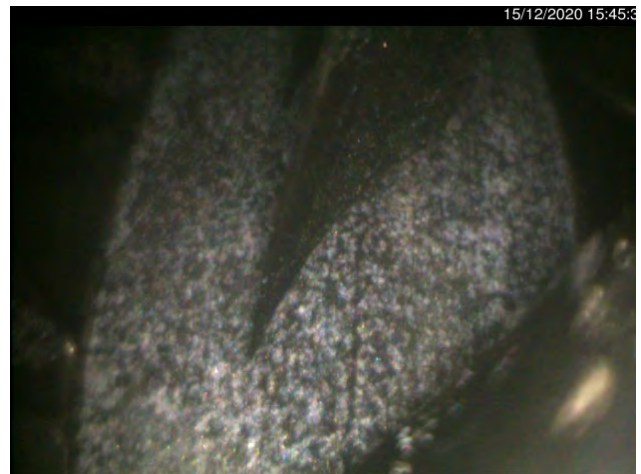
Picture 10: salts and deposits

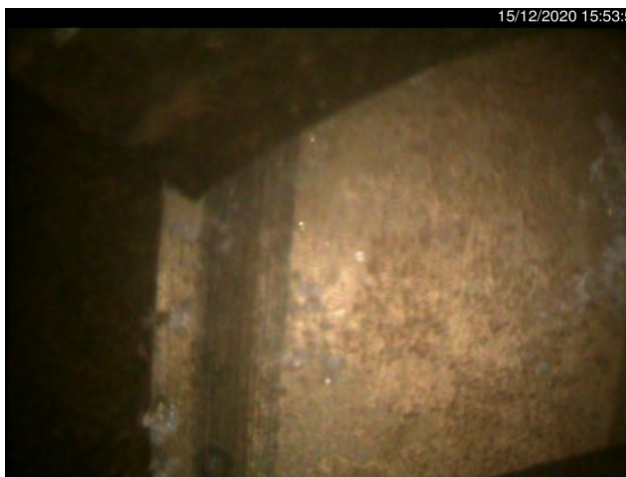
Picture 11: rub marks

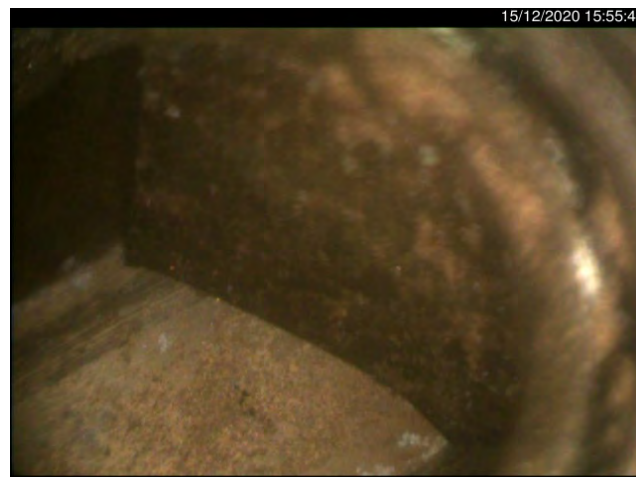
Picture 12: rub marks

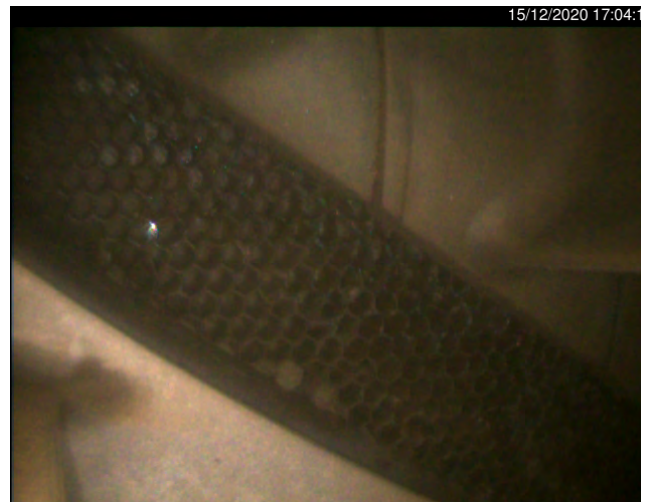
Picture 40: LPT stage 1 blades, sealing

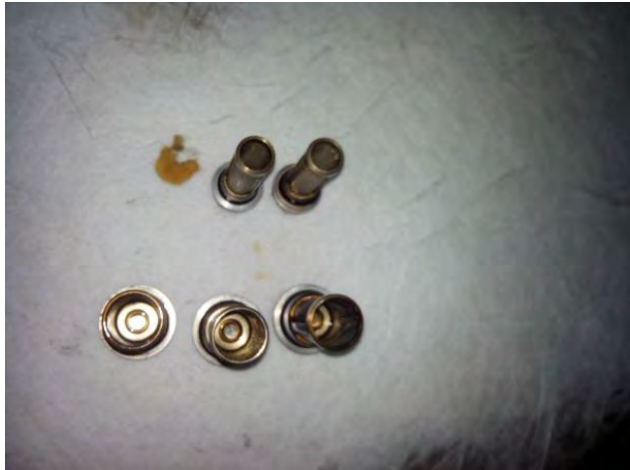
Picture 46: screen
All screens and chip detectors clean.
No remarks
